**REPORT AND SPECIFICATION
FOR
RESTORATION WORKS
ON NELLIES GLEN ROAD and THE 6 - FOOT TRACK
NELLIES GLEN**

**Prepared for
Crown Lands, Parramatta**

DEPARTMENT OF LANDS
SOIL CONSERVATION SERVICE
Greater Metropolitan Office
Level 12, 10 Valentine Ave
Parramatta NSW 2150

Date: August 2005 Revision No	Author: A.Scott Reviewed by
--	----------------------------------	--------------------------------

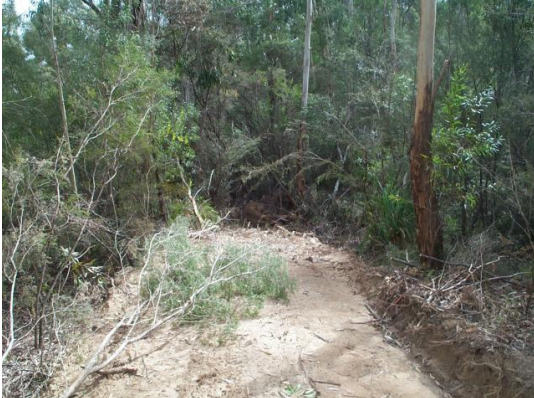
Issue	Remediation	Image	EAST	NORTH
The mitre drain has been extended to far.	Where the mitre drain fall exceeds 5°, the soil will be reformed to create a bank and the disturbed vegetation will be pulled back to protect the soil. In addition, coir fibre logs will be installed where necessary to trap sediment and slow water flow.

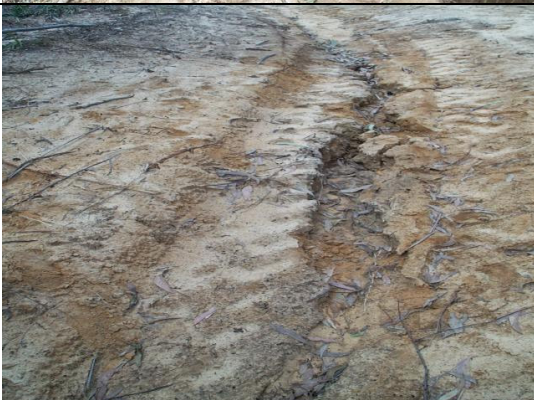
245899.321	6264227.326
The mitre drain has been extended to far. The fall is too great and erosion is already occurring.	Where the mitre drain fall exceeds 5°, the soil will be reformed to create a bank and the disturbed vegetation will be pulled back to protect the soil. A rock check dam may be required. In addition, coir fibre logs will be installed where necessary to trap sediment and slow water flow.

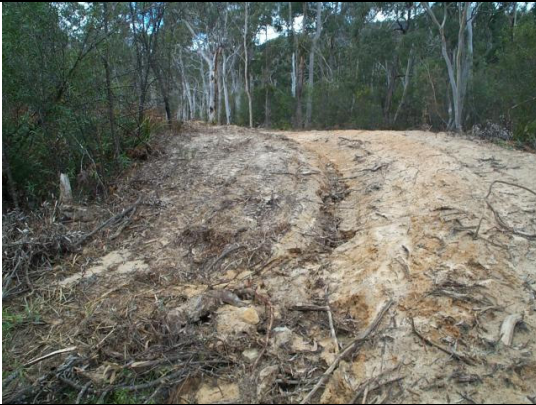
ISSUE	REMEDIATION	IMAGE	EAST	NORTH
<p>Extensive clearing around mitre drains.</p> <p>Fall of drain to great.</p>	<p>Rock checks will be installed to slow water and prevent erosion.</p> <p>Vegetation will be respread and / or brush-matting applied.</p>

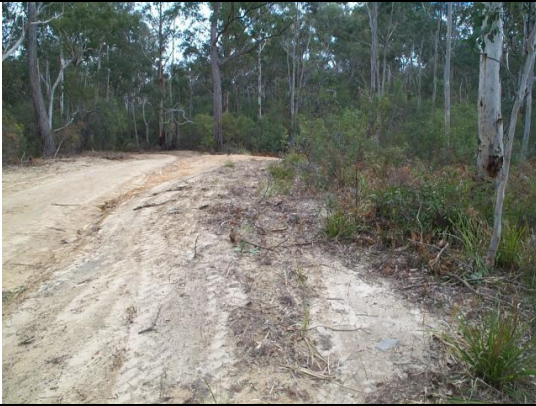
<p>246008.731</p>	<p>6264331.022</p>
<p>Verge cleared</p>	<p>Brush-matting will be installed to protect soil surface.</p>

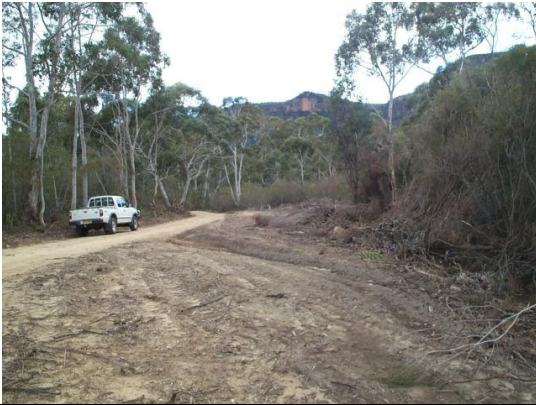
<p>246019.877</p>	<p>6264333.953</p>
<p>Extensive clearing of vegetation during installation of mitre drains</p>	<p>Vegetation and topsoil will be respread and erosion and sediment controls implemented (ie coir fibre logs installed across the slope to intercept water.</p> <p>Brush-matting will be used to cover any remaining bare soil.</p>

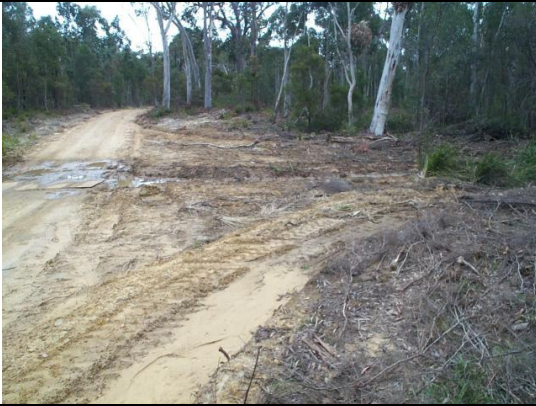
<p>246207.878</p>	<p>6264368.655</p>
<p>Extensive clearing of vegetation around drainage line.</p>	<p>As above</p>
